DRIVEWINDOW LIGHT, DRIVESTUDIO OR DRIVELoader IS VERY SLOW OR STOPS RESPONDING

Author: Jeff Fell – Application Eng.		Date: November 2011
External	Industry – Industrial, HVAC	Document #: LVD-EOTN34U-EN
http://www.abb.us/drives		Revision: A
Product Categories: ACS55, ACS150, ACS350, ACS355, ACS310, ACS320, ACS550, ACH550, ACS800, ACS850, ACSM1, DCS800

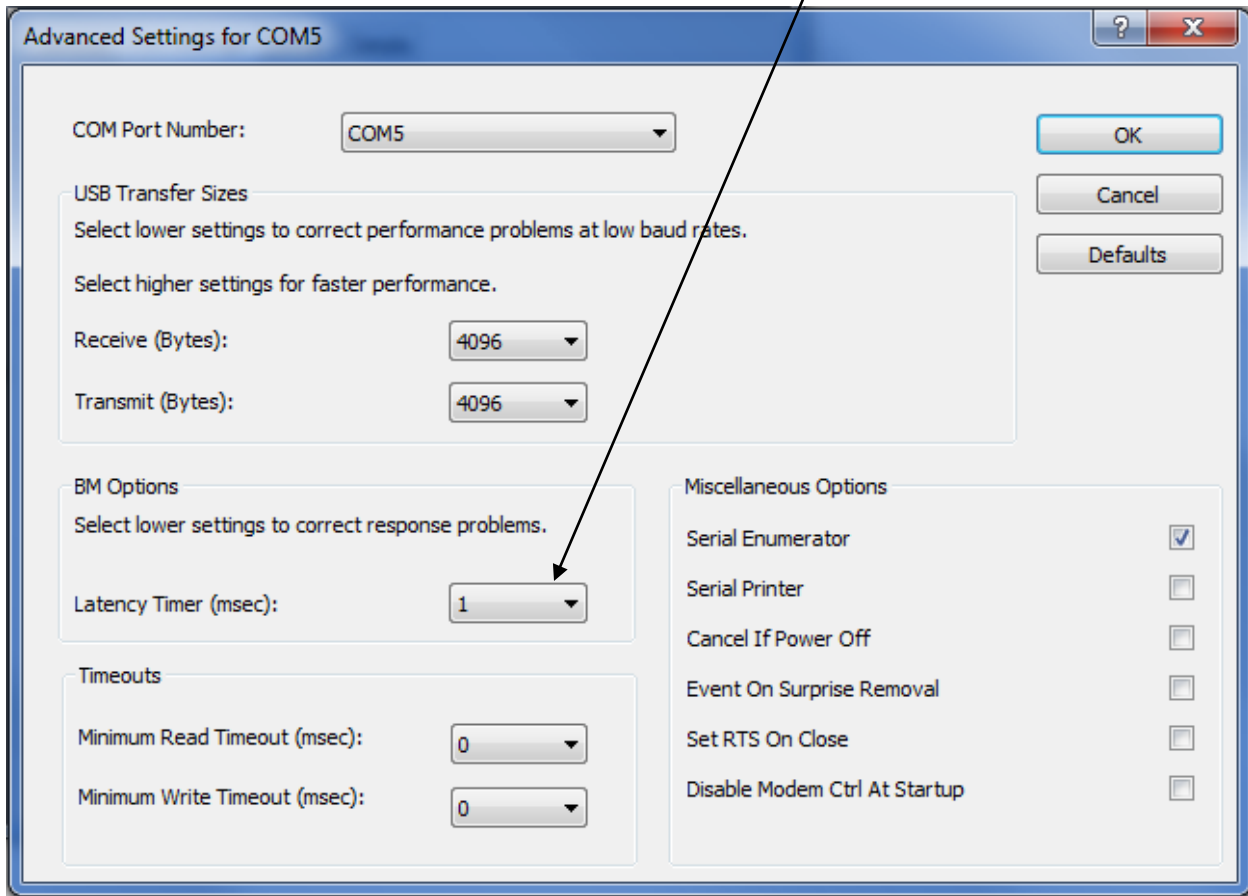
The latency timer for the USB to serial port might need to be adjusted within the computer.

- Set the Latency Timer setting from 16msec to 1msec.
